Manhole Inspection Summary

Manhole # S41E__067MH

Insp Date: **11/24/08 11:12 AM**

Location Address: **4 n. central av**

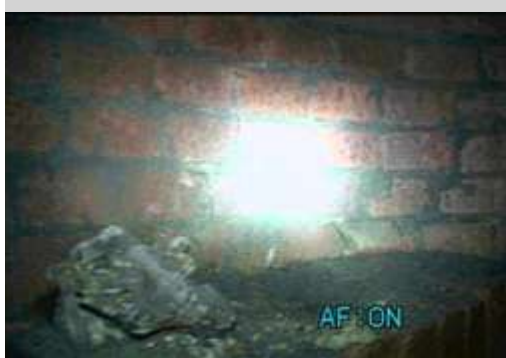
MISC

bench debris

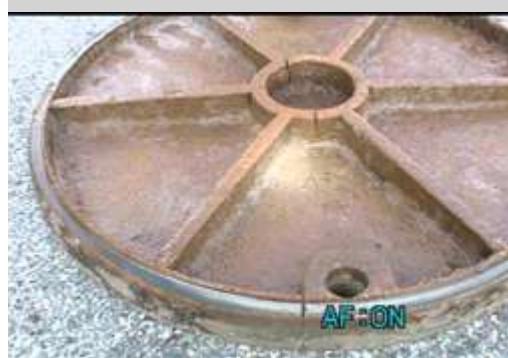
Defect 6

cracked cover

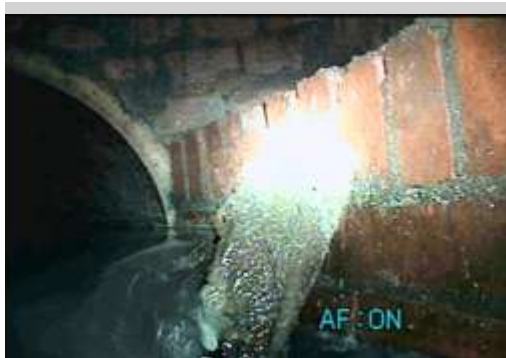
Defect 4

channel debris

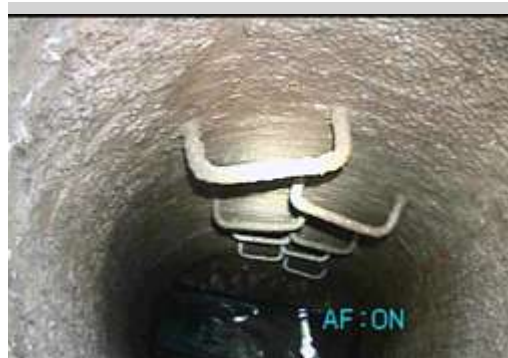
Defect 3

steps corroded

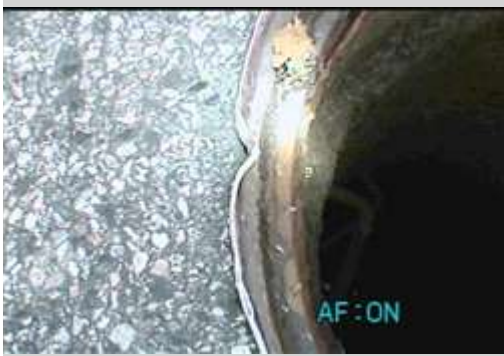
Defect 2

frame cracked/lip bent

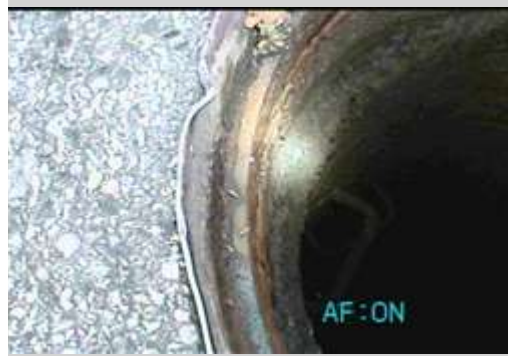
Defect 1

frame offset 2 inches
